HISTORY
of
TASK GROUP 7.4
participation in
OPERATION CASTLE
1 January 1953 - 26 June 1954

H I S T O R Y
of
T A S K G R O U P 7.4
participation in
OPERATION CASTLE

Prepared by the Historical Division
Office of Information Services
Air Force Special Weapons Center

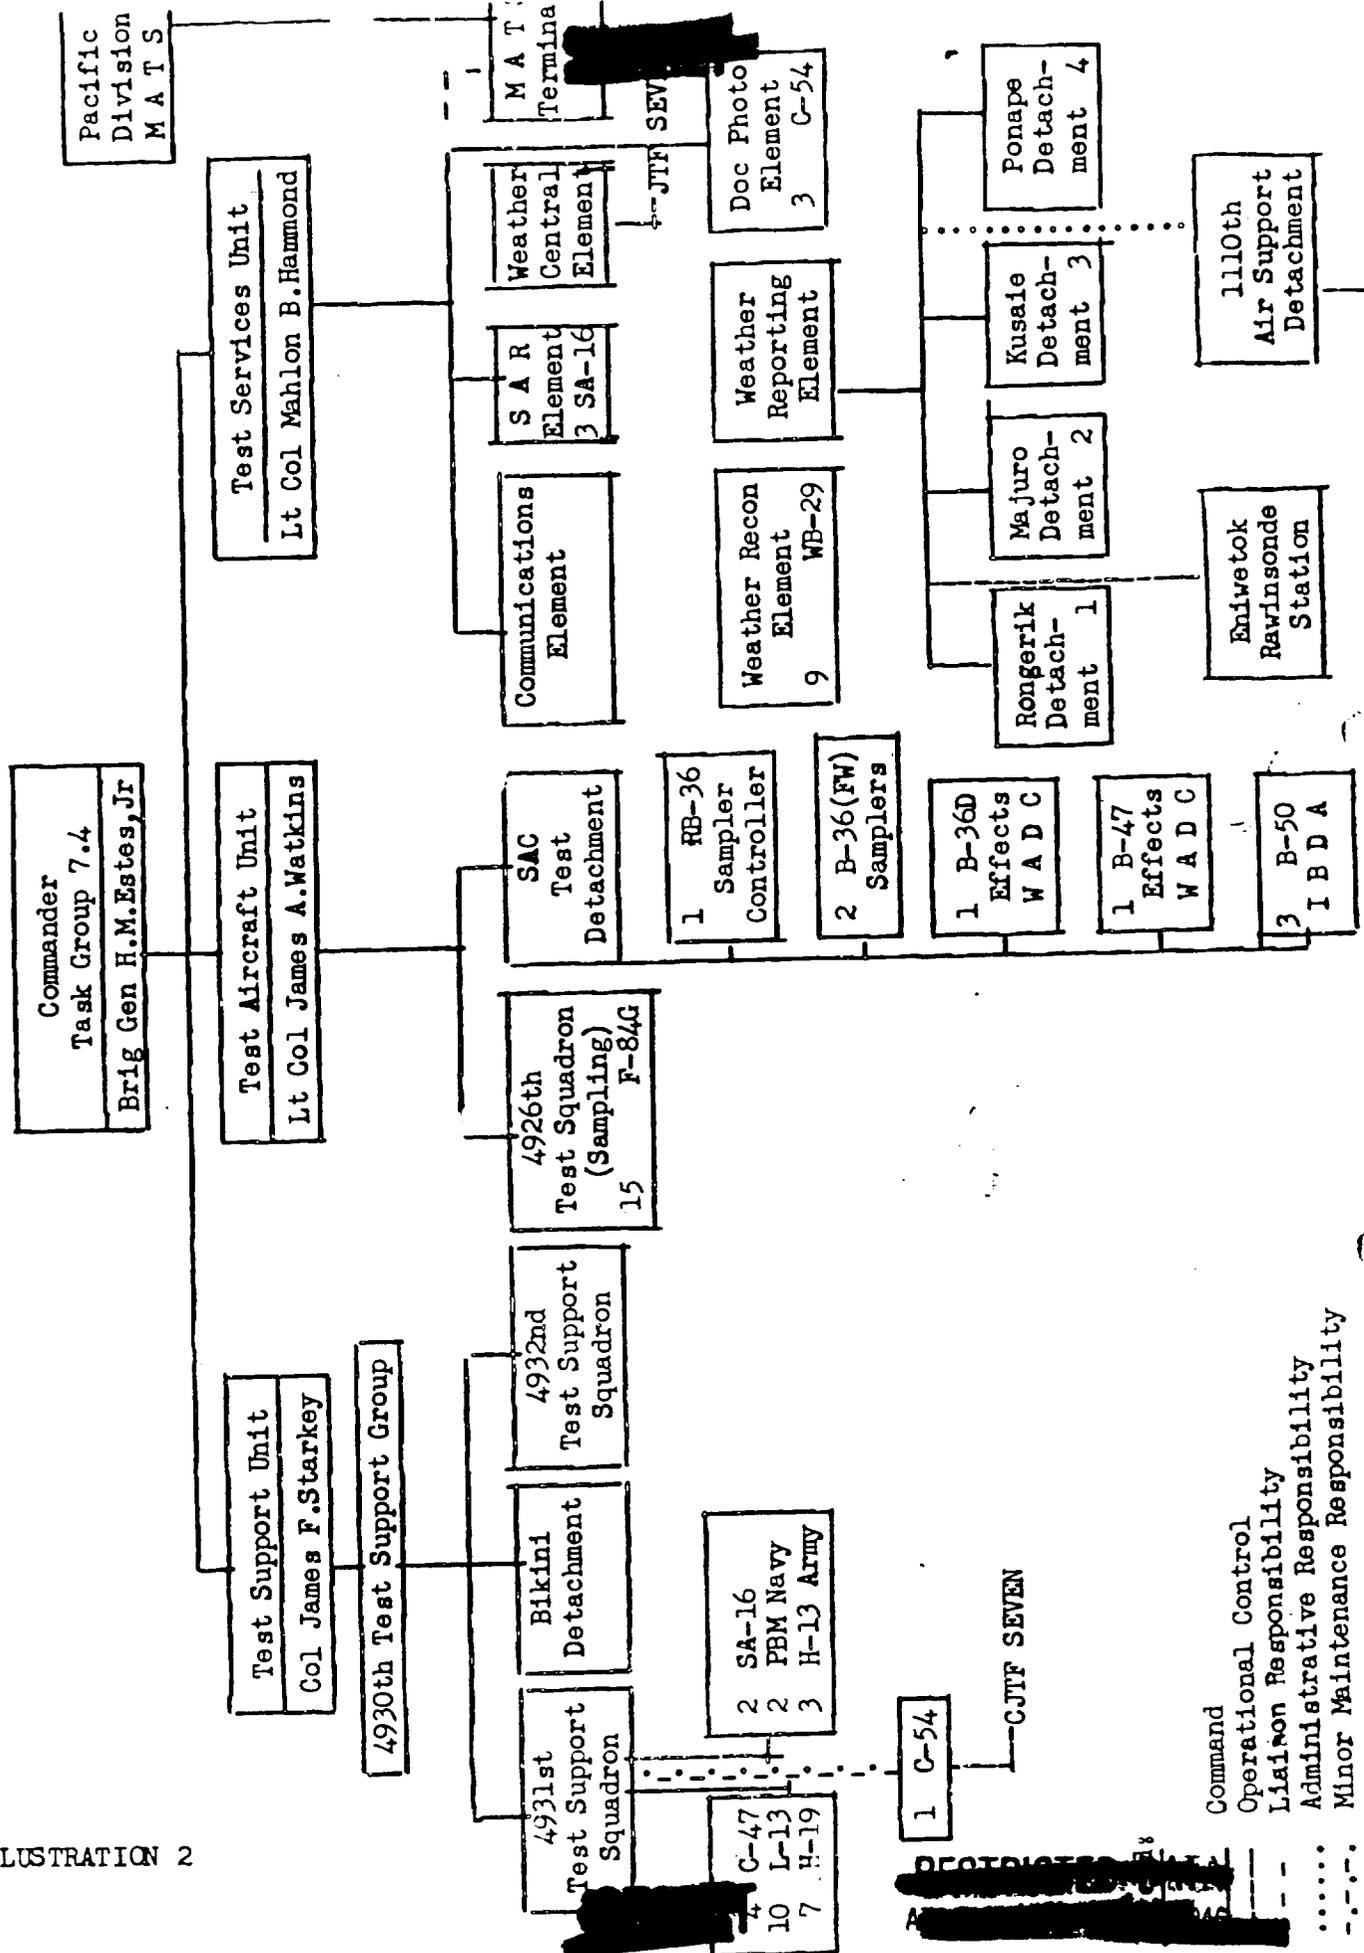
ILLUSTRATION 2

ORGANIZATION OF TASK GROUP 7.4

The Air Task Group was to be composed of Headquarters, Task Group 7.4, Provisional; the 4930th Test Support Group; the 4931st and 4932nd Test Support Squadrons; a cloud sampling and control detachment; an effects test detachment; a weather reconnaissance detachment; a documentary photo detachment; a weather detachment; and an aircraft control and warning detachment.³ ILLUSTRATION 2, opposite page, shows the organization of TG 7.4.

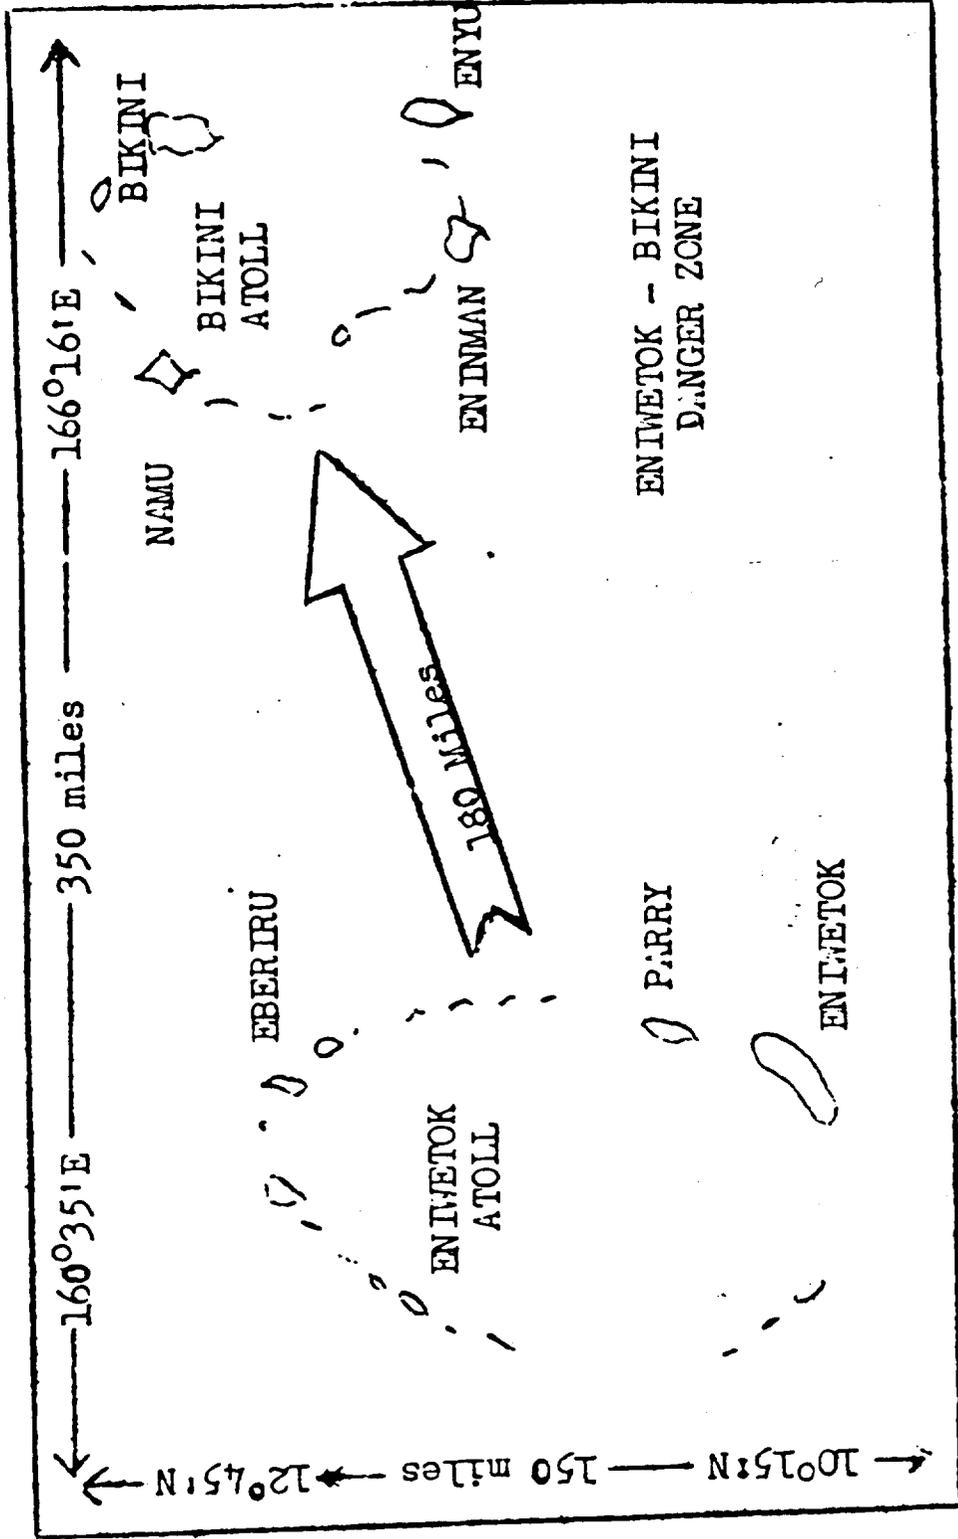
ILLUSTRATION 11

OPERATION CASTLE (~~REDACTED~~)
DANGER ZONE
